Case Report

Direct composite coronal reconstruction of two fractured incisors: an 8-year follow-up

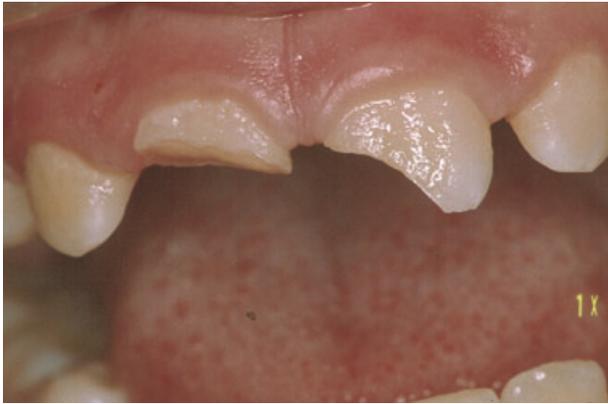
A 10-year-old patient attended our clinic because of a trauma that caused a fracture in the mesial angle of the maxillary left central incisor that affected enamel and dentine, and a horizontal fracture of maxillary right central with a pulp exposure (Figs 1 and 2). A periodontal and radiographic examination was performed and ruled out any root fractures. Because of the fact that lost fragments were not

Fig. 1. Superior central incisor, preoperation view in a 10-year-old male.

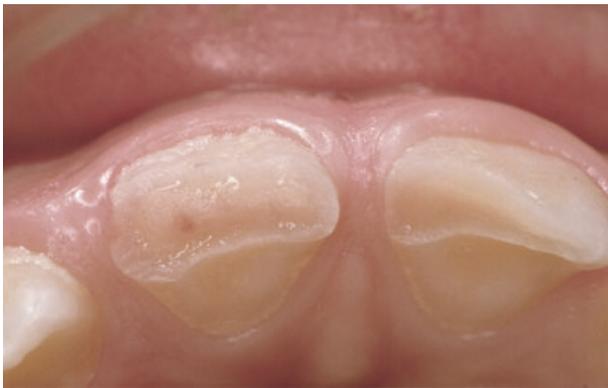
Fig. 2. Incisal view. Pulpar implication of fracture clear in superior right central incisor.

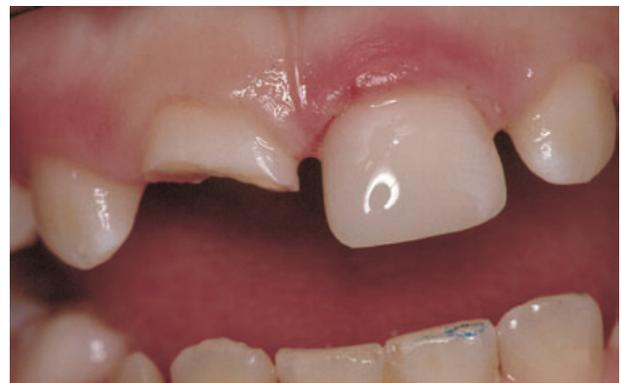
Fig. 3. Reconstruction of left central incisor. Transparent acetate crown used as a matrix.

With the excess removal and proper polish, a uniform and continuous surface in the tooth-restoration junction is obtained, without any irregularities that would contribute to the accumulation of plaque. For that task a carbide multiblade bur is ideal, preferably with a worn edge that would allow a gradual wear out of the composite avoiding irregularities in the cement or the restoration. A probe was run over the cervical area to assure uniformity of the surface. For the labial surface polish discs were used, along with polish strips for the interproximal surface (Sof-Lex, 3M ESPE Dental Products, St Paul, MN, USA) (Fig. 3).

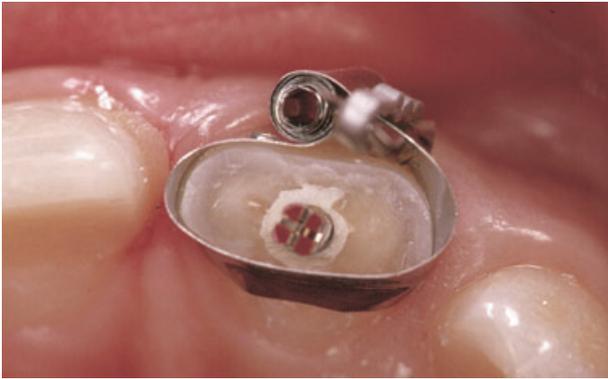
Fig. 4. Unimetric® post (Dentsply) cemented in right central incisor using glass ionomer. Automatrix® (Dentsply) surrounding tooth used to construct composite core.

For the upper right central a root canal treatment was performed and in the following visit a titanium-prefabricated post (Unimetric, Dentsply, Ballaigues, Switzerland) was cemented using glass ionomer (Fuji I, GC Corporation, Tokyo, Japan). The post must

Because of gingival proximity of the fracture the restoration was practiced in two steps. First an Automatrix® (Dentsply Detrey, Konstanz, Germany) was adapted to perform a core of opaque composite (Fig. 4). Subsequently and after removal of the matrix, the composite core was prepared ensuring a wide bevel that entailed the composite core and the remaining enamel (Fig. 5).

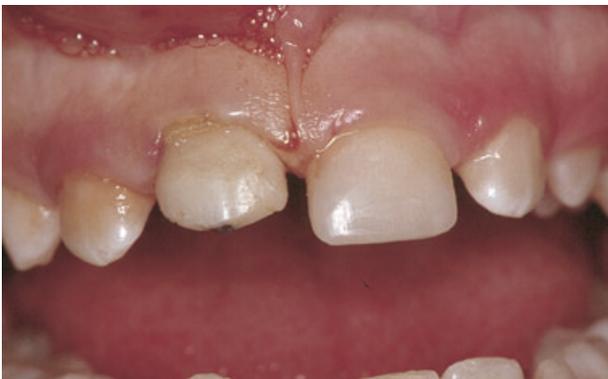
Fig. 5. Opaque composite core on top of which direct reconstruction will be realized.

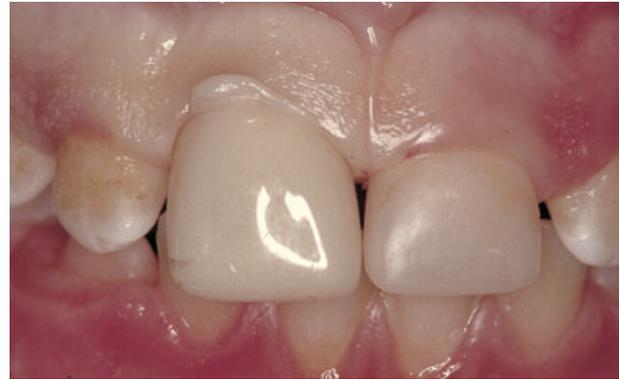
Fig. 6. Cellulose acetate crown filled with composite and situated in its position, the over flow of composite is eliminated before final curing.

composite and immediately after, an instrument is introduced to allow some space for the remaining tissue, whilst avoiding the excessive outflow of composite in the cervical region (Fig. 6). Once the crown is placed with the adequate orientation excess composite is removed through the aperture in palatine and gingival surface of the acetate crown. After withdrawal of the acetate crown a

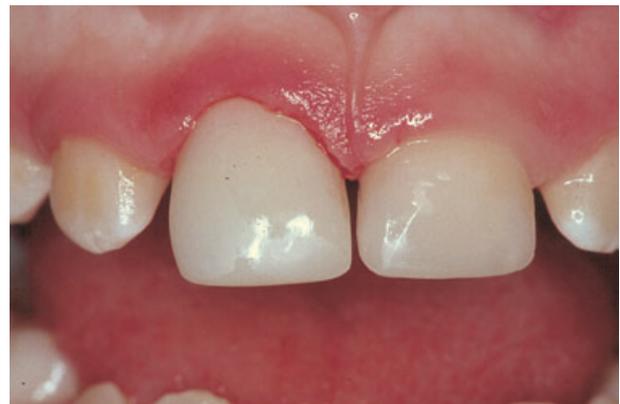
Fig. 7. Finished restoration of both superior central incisors.

gingival contour polish is performed using multi-blade carbide burs. In addition, fine grain polish discs were used to obtain the ultimate shape of incisal edges and angles (Sof-Lex, 3M ESPE Dental) (Figs 7–9). A few days later the restoration is revised to verify gingival health and correct possible esthetic and polishing defects that might have occurred.

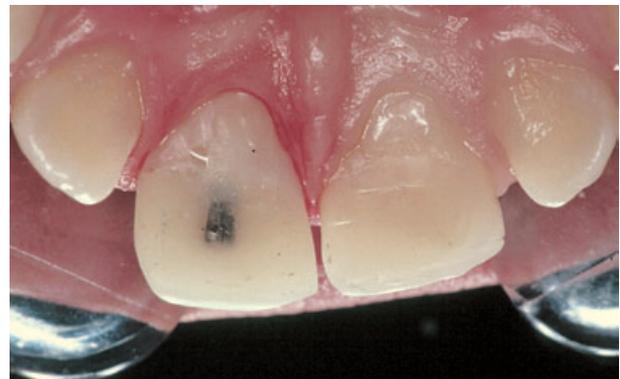
Fig. 8. Palatine view of both restorations. Integrated post can be appreciated.

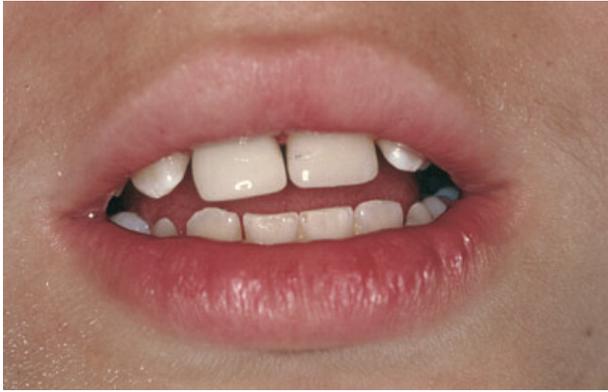
Fig. 9. General aspect of reconstruction immediately after rehabilitation.

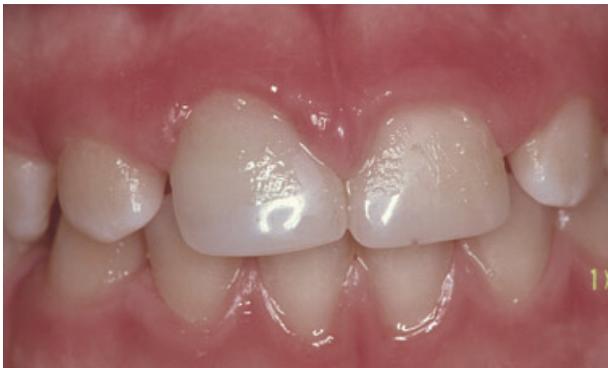
A year later the patient returned for a review examination. The restorations were found to be in excellent condition, although a slight gingival inflammation was noticed in the papilla, between the central incisors, caused by a composite irregularity detected in the area (Fig. 10). Fine polish strips were used to reduce the surface and promote healing of the papilla. The maxillary and dental maturation had closed the incisor diastem and slightly inclined the upper right central.

Fig. 10. One-year control examination. Slight gingivitis in papilla between central incisors is obvious. Found to be because of polish defect and subsequently eliminated using polish strips.

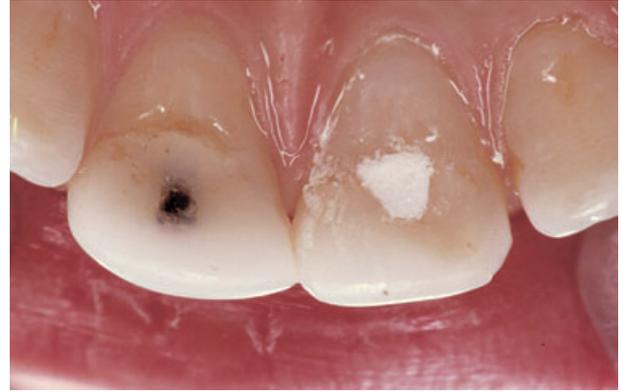
Fig. 11. Composite clearing out, along with, a staining of the interface (composite–teeth junction) is observed. In teeth 12, opening for the root-canal treatment.

required root canal treatment and the cementation of a titanium post (Fig. 11). The possible causes of this rather late pulpal inflammation were not clear, but marginal filtration in the restoration might be a possible cause.

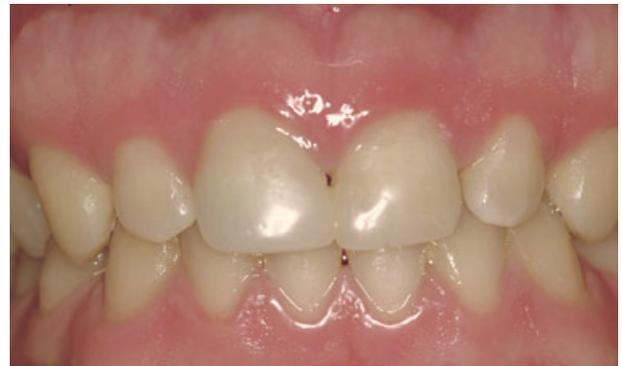
Despite the fact that the restoration was projected as a temporary treatment whilst awaiting an adequate maxillary growth of the patient, the durability of the treatment confirms that with proper case selection, this kind of treatment may be feasible in the long-term (Fig. 12) (7).

Fig. 12. Eight years, most recent follow-up photograph with a fully normal and functional aspect of restoration.
